RETAINING WALL REPAIR

American Self Storage

Austin, TX

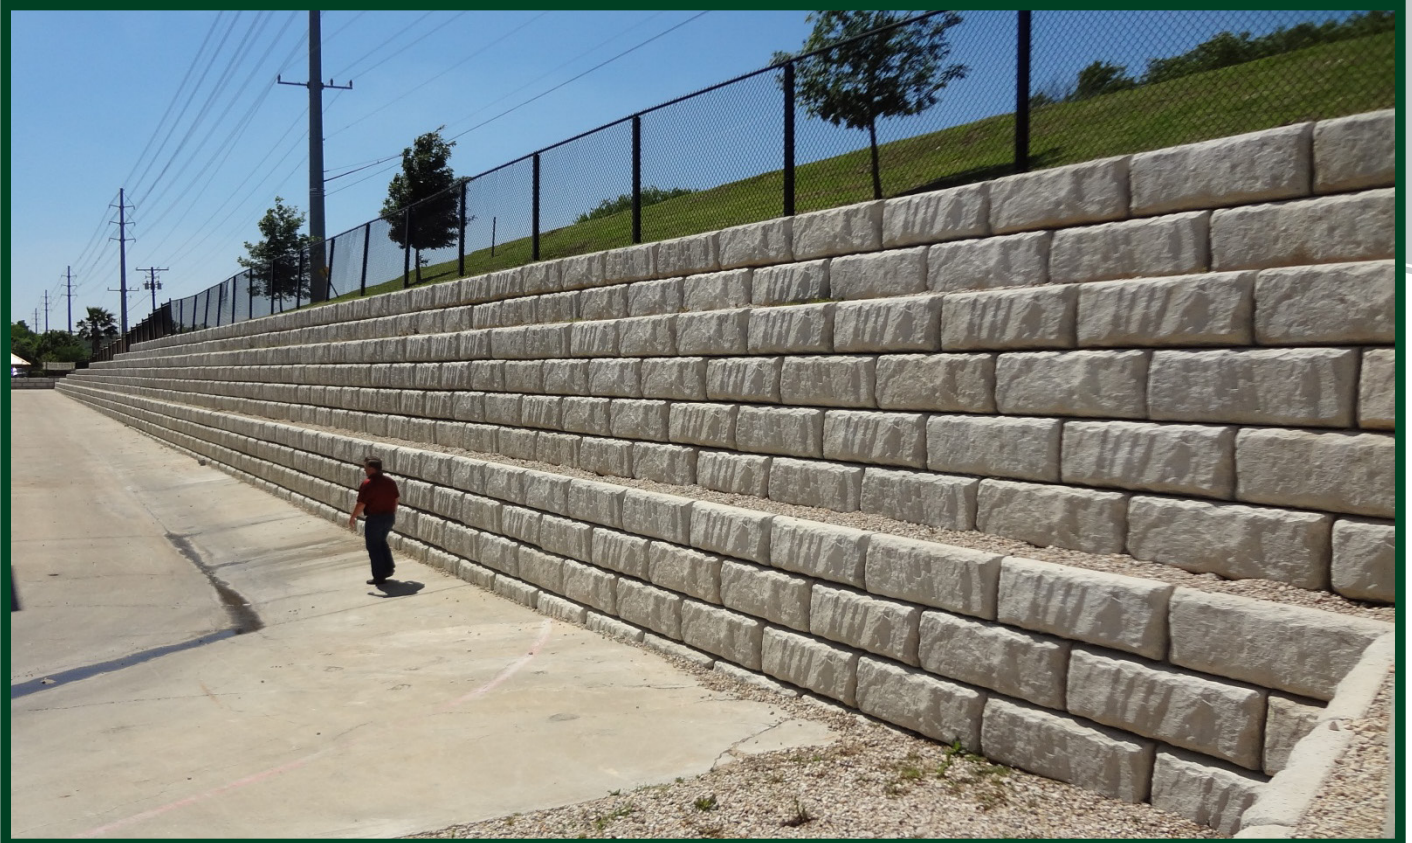
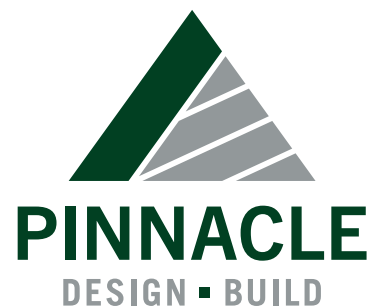
A poorly constructed cast-in-place concrete retaining wall supporting the slope next to this self storage facility failed catastrophically. The failure also put an adjacent high pressure gas line at risk.

Pinnacle Design/Build designed a gravity retaining wall using Redi-Rock™ large block units to replace the failed wall. Our crews carefully demolished and removed the failed structure and replaced it without incident.
