ROCK FILLED WELDED WIRE BASKET RETAINING WALL REPAIR

Lowe's Home Improvement
Bullhead City, AZ

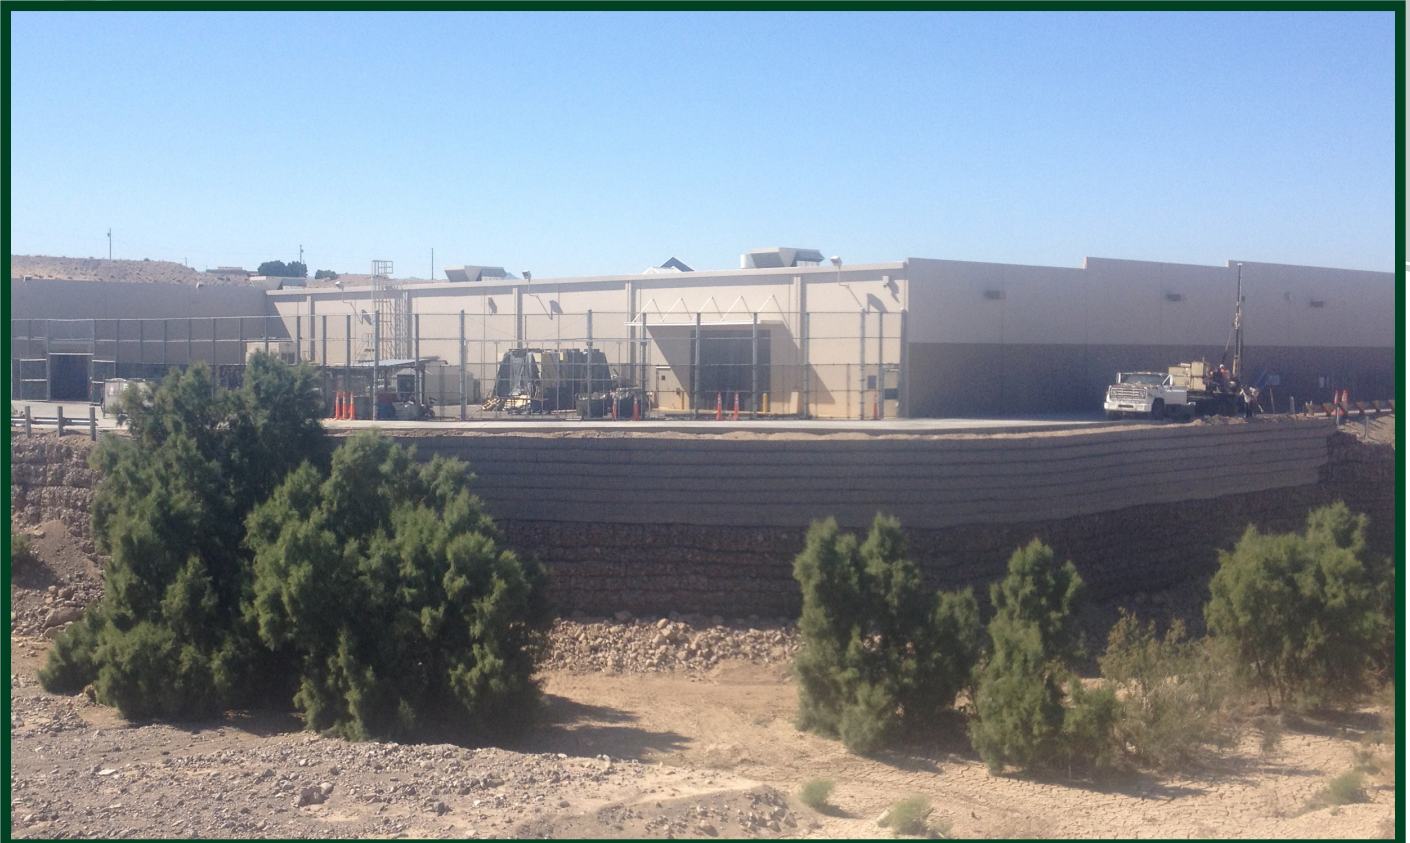
The top portion of the existing retaining wall at the site of a large retailer was beginning to fail, causing substantial cracking of the asphalt and foundation of the store.

Pinnacle Design/Build's experienced construction crews and management team worked with the developer to construct a 10 foot tall, 1,748 square foot Rock Filled Welded Wire Basket Retaining Wall to support the store.

The bottom half of the existing retaining wall was still functional. Pinnacle's construction crew was able to build on top of the existing wall to replace the failing portion of the wall, saving the developer time and money on the repair.
